LOW-EARTH ORBIT EFFECTS ON ORGANIC COMPOSITE MATERIALS
FLOWN ON LDEF*

Pete E. George

Harry W. Dursch

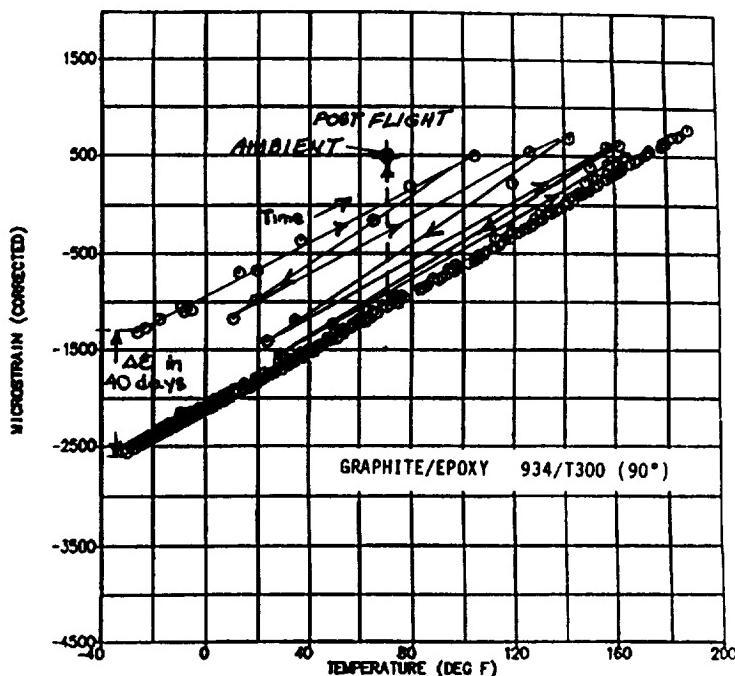
Analysis of dimensional stability data collected on-orbit revealed dimensional changes as a result of both outgassing and thermal cycling (ref. 1). Results for on-orbit measurements of 90° direction strain versus temperature of unidirectional fiber-reinforced organic composites revealed a 40-day period of changing coefficient of thermal expansion (CTE) as the specimen outgassed. The CTE asymptotically approached and reached the preflight value during these 40 days. Moisture desorption was cited as the most likely cause of the shrinkage and changing CTE. On-orbit measurement of 0° CTE did not reveal any significant changes. These results verified the investigators' ground-based simulation predictions. These dimensional changes must be factored into the design of low distortion OMC laminates.

Figure 4. Effects of outgassing and thermal cycling on dimensional stability for an LDEF graphite-reinforced OMC.

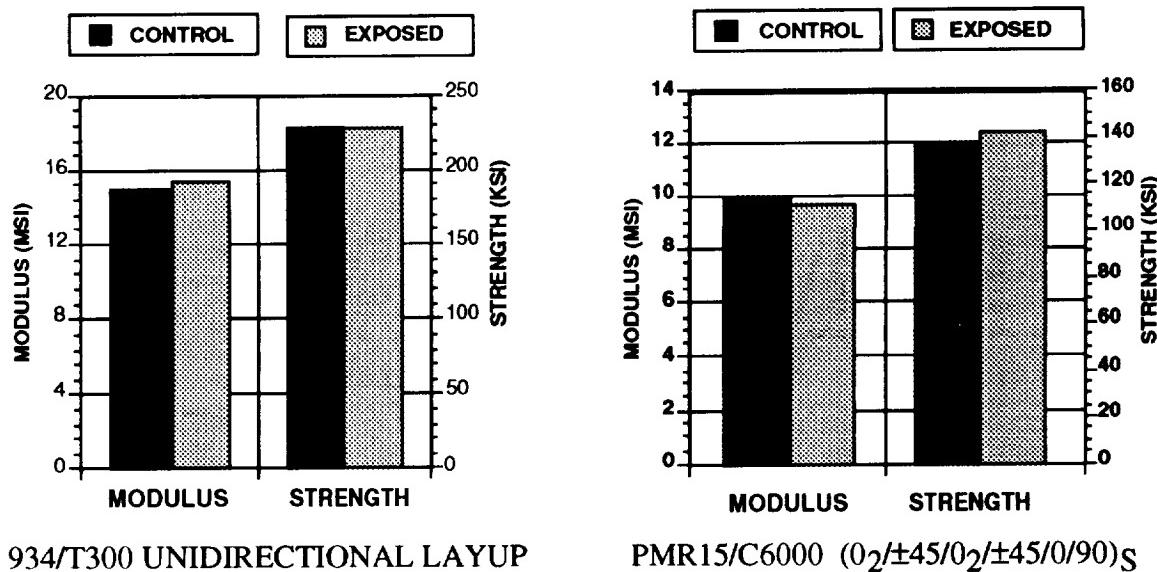
No mechanical property changes were attributed to UV exposure effects. Figure 7 shows the flexural strength and modulus results for both control and flight specimens (ref. 4). No significant changes were found for these materials as well as other graphite-reinforced OMC's. Glass-reinforced OMC's flown in AO-shielded, UV-exposed positions did display visible signs of UV degradation.

Figure 7. Typical flexural mechanical property changes for AO-shielded, UV-exposed LDEF graphite-reinforced OMC's.

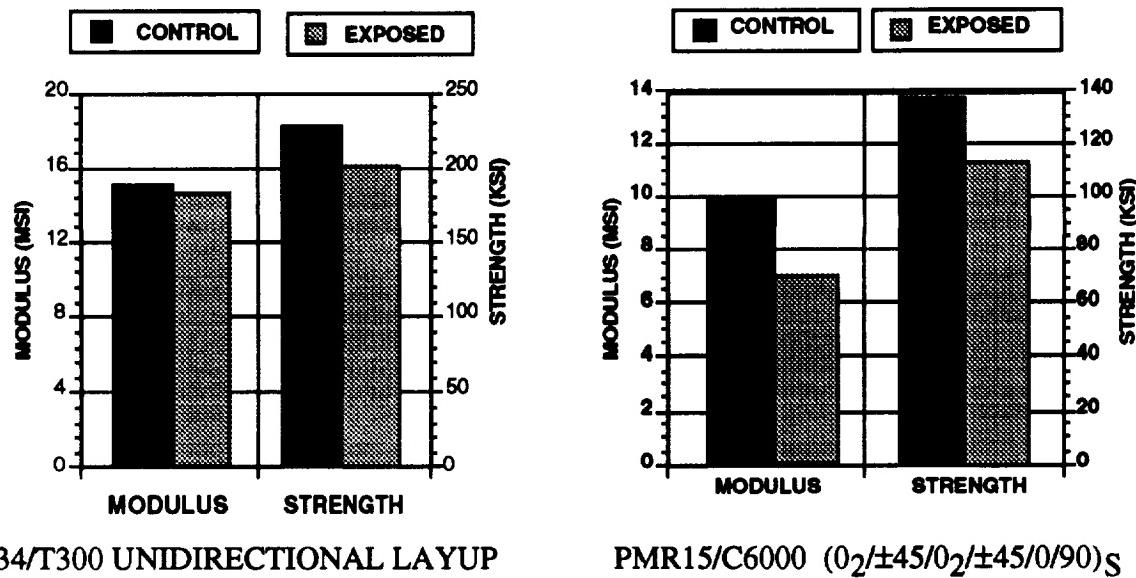
For unidirectionally reinforced specimens, the reduction in mechanical properties was found to be proportional to the reduction in specimen cross-sectional area. Therefore, as shown in Figure 11 for the AO and UV exposed T300 graphite /934 epoxy specimens flown on M0003-8, there was little change in modulus based on postflight specimen cross-sectional area. Strength values may have been effected by AO erosion-created stress concentration sites. Although useful for determination of lamina properties, unidirectional layups are rarely used in real applications due to the highly isotropic nature of the material.

Figure 11. Typical flexural mechanical property changes for AO- and UV-exposed LDEF graphite-reinforced OMC's.

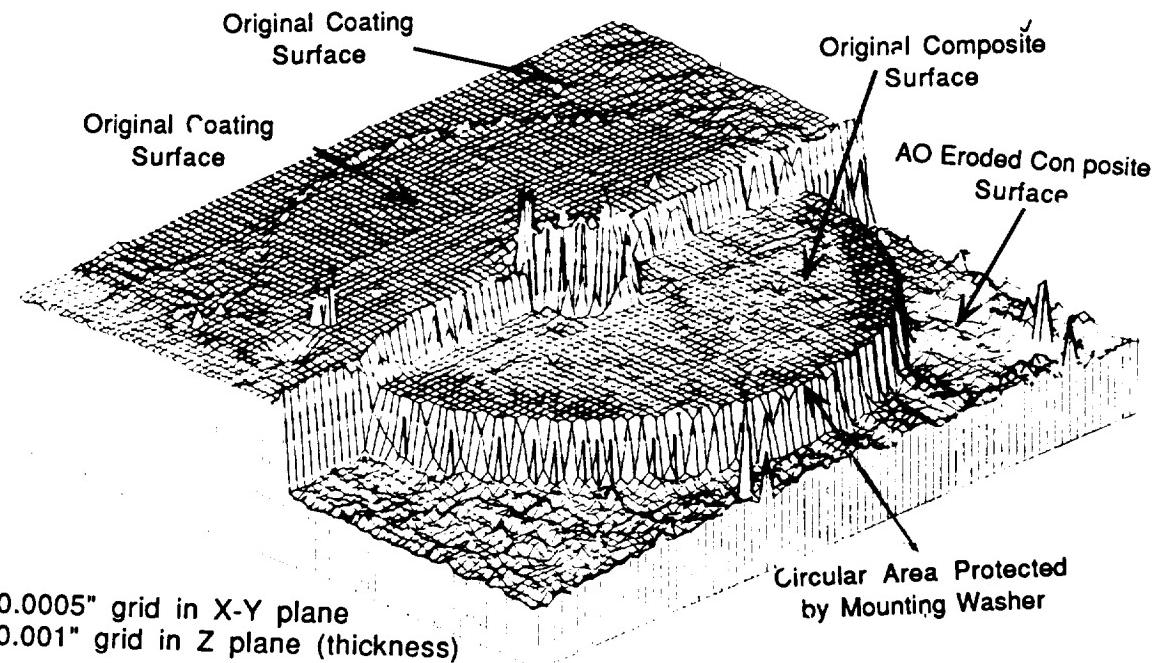
Figure 14 is a three-dimensional plot of the data collected during a laser profilometry raster scan of a portion of the panel shown in Figure 13. The data are plotted as a 0.0005-inch grid for the x-y plane and 0.001-inch line segments of various thicknesses for the z-direction (depth). The approximately 1-in² area contains a circular region shielded from AO attack by a mounting washer on the surface. An A276 white polyurethane coating covers the rear left half of the panel segment. The A276 coating was clearly effective at preventing AO erosion of the underlying OMC substrate. However, AO erosion was observed by different investigators in areas where the protective coatings had been breached by impacts or cracks.

Figure 14. Three-dimensional plot of profilometry measurements taken from a partially coated graphite-reinforced OMC.

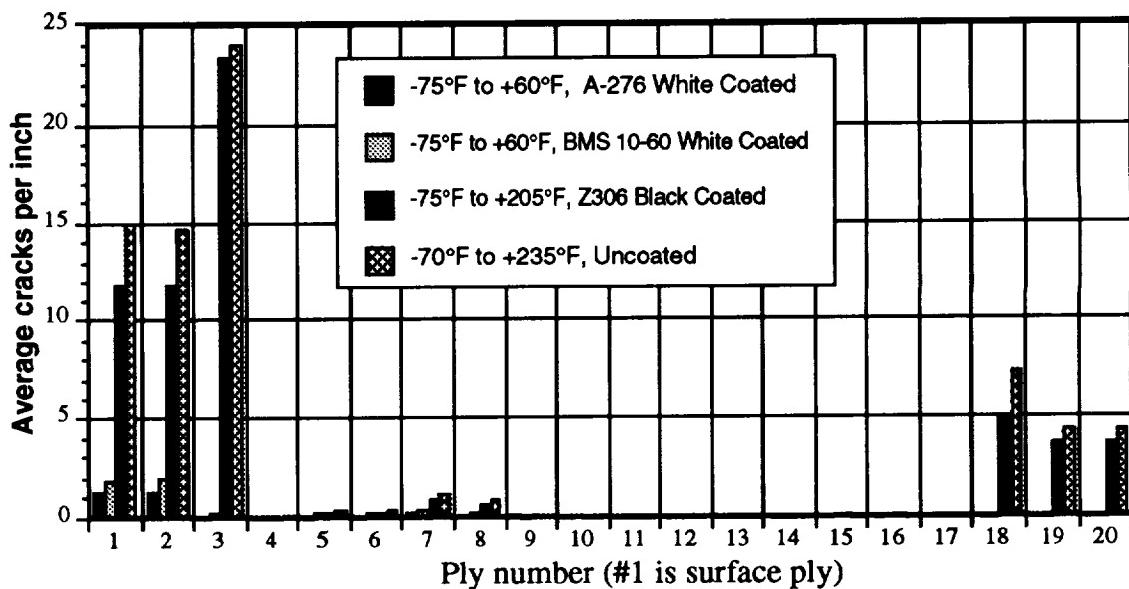
934 epoxy/T300 Graphite (0₂, ±45, 0₂, ±45, 90, 0)_S

Figure 15 shows the effectiveness of coatings possessing optimum optical properties for the minimization of thermally induced microcracking of the composite substrate. This is accomplished by passively controlling the thermal cycling extremes and thermal shock seen by the underlying composite substrate. This figure shows the postflight measured microcrack density versus thermal cycling conditions for the coated composite panel shown in Figure 13 (ref. 3). Crack density is measured from polished cross sections at $\times 200$ magnification. Thermal cycling conditions were estimated using LDEF environmental data (ref. 6), physical and optical properties, and recorded flight data for an underlying structure. The increased crack density for the more severely cycled material is most likely due to the thermal shock as the energy input was into one side of the specimens in the form of solar exposure. No inflight measurement of dimensional stability versus microcracking data is yet available. However, the impact of microcracking on dimensionally critical spacecraft hardware has been a design issue in past experiences such as the Hubble space telescope optical truss assembly.

The significance of these findings is that microcracking was prevented by reducing the thermal cycling extremes and shock, in this case through the use of reflective optical coatings.

Figure 15. Microcrack density and distribution in an LDEF OMC for various thermal environments.
